# Manhole Inspection Summary

Manhole # S49AA\_030MH

Insp Date: **7/10/08 9:11 AM**

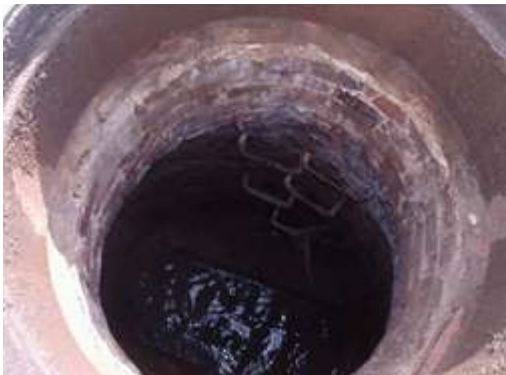
Defect 1

Infiltration: ☐ None ☐ Joint ☐ Cracks ☒ **Mortar** ☐ Roots ☐ Wall

Infiltration: ☐ None ☐ Joint ☐ Cracks ☐ Mortar ☐ Roots ☒ **Wall**

Infiltration

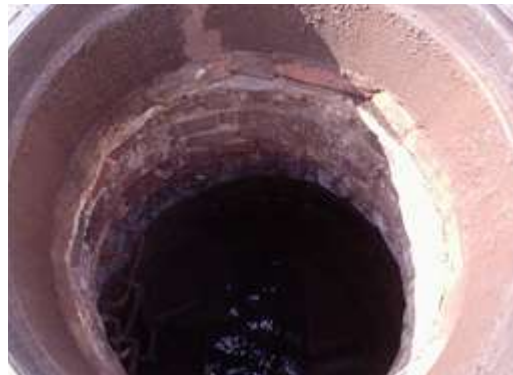
Defect 2

frame leaks

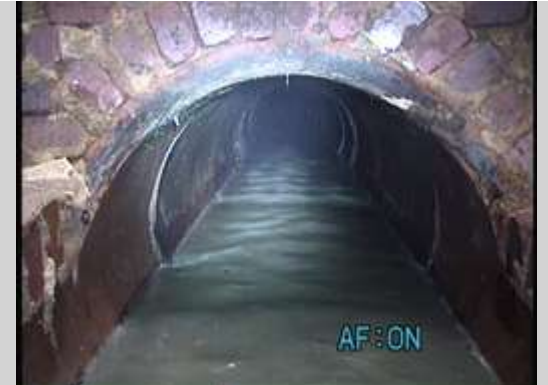
12 O'Clock Outflow

24 in. Circular Gravity Sewer  
Pipe Out @ 12 O'Clock

Pipe Height: **24** (in.) Rod and Bar (Angled)  
Pipe Material: **Clay** ☐ Pipe Lined  
Invert Depth: **11.10** (ft.) Flow Characteristics: **Fast**  
Deposits: ☒ None ☐ Mud ☐ Sludge ☐ Debris ☐ Grease  
Silt Depth: (in.) Deposits Extent:  
Infiltration: **None** Pipe Seal Cond: **Sound**

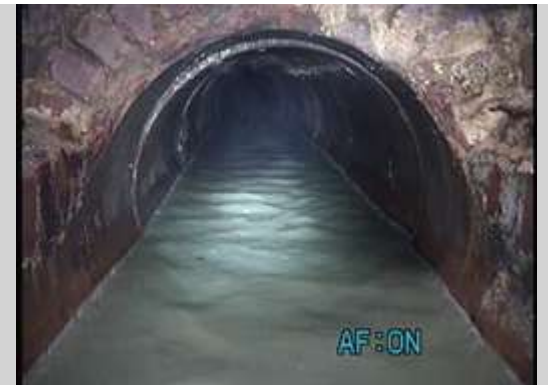
6 O'Clock Inflow

24 in. Circular Gravity Sewer  
Pipe In @ 6 O'Clock

Pipe Height: **24** (in.) Rod and Bar (Angled)  
Pipe Material: **Clay** ☐ Pipe Lined  
Invert Depth: **11.00** (ft.) Flow Characteristics: **Fast**  
Deposits: ☒ None ☐ Mud ☐ Sludge ☐ Debris ☐ Grease  
Silt Depth: (in.) Deposits Extent:  
Infiltration: **None** Pipe Seal Cond: **Sound**

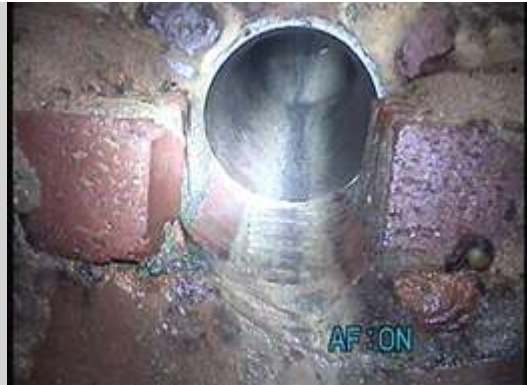
9 O'Clock Inflow

8 in. Circular Gravity Sewer

Pipe In @ 9 O'Clock

Pipe Height: **8.4** (in.) Rod and Bar (Angled)

Infiltration: **None** Pipe Seal Cond: **Sound**
